CONNECTICUT RIVER BASIN  
SUFFIELD, CONNECTICUT

# SCHWARTZ POND DAM CT 00280

PHASE I INSPECTION REPORT  
NATIONAL DAM INSPECTION PROGRAM

APRIL 1981

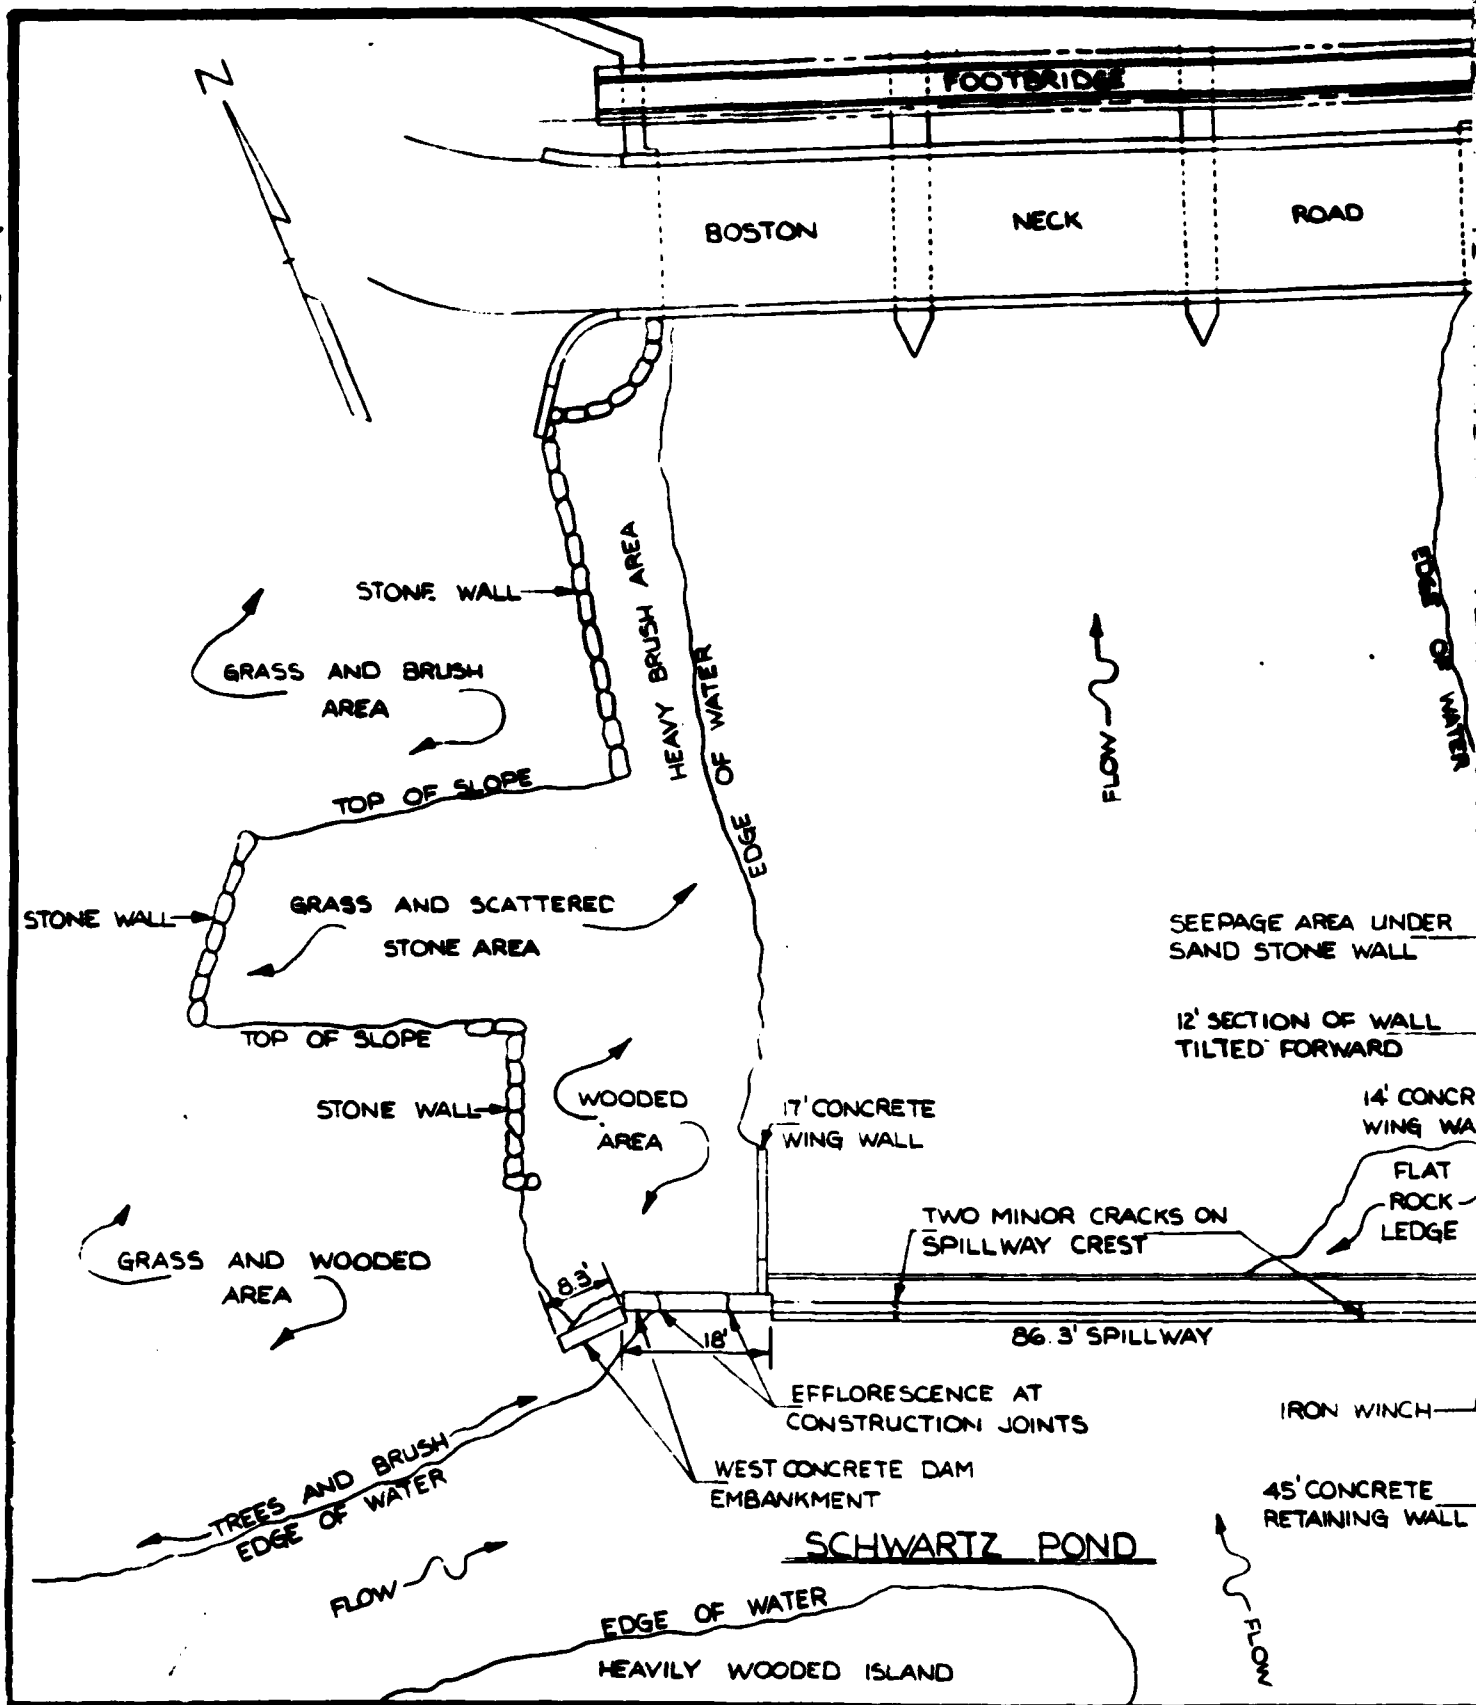
Seepage was observed under the sandstone wall, east of the spillway, as noted on the general dam plan in Appendix B. The seepage flowed steadily, but was small and appeared to be free of any soil particles. A 12 ft. portion of this sandstone wall, which is abutting the stone slope, was also observed to be tilting forward (See general dam plan in Appendix B).
